# The 2019 Brumadinho tailings dam collapse: Possible cause and impacts of the worst human and environmental disaster in Brazil

On 25th January 2019, the tailings dam of the Brumadinho iron mine operated by Vale S/A failed catastrophically. The death toll stood at 259 and 11 people remained missing as of January 2020. This tragedy occurred three years after Mariana's tailings dam rupture – the most significant tailing dam disaster in Brazilian history. Thus far, a systematic investigation on the cause and effect of the failure has yet to be conducted. Here, we use satellite-driven soil moisture index, multispectral high-resolution imagery and Interferometric Synthetic Aperture Radar (InSAR) products to assess pre-disaster scenarios and the direct causes of the tailings dam collapse. A decreasing trend in the moisture content at the surface and the full evanescence of pond water through time (2011–2019) suggest that the water was gradually penetrating the fill downwards and caused the seepage erosion, saturating the tailings dam. Large-scale slumping of the dam (extensional failure) upon the rupture indicates that the materials of the fill were already saturated. InSAR measurements

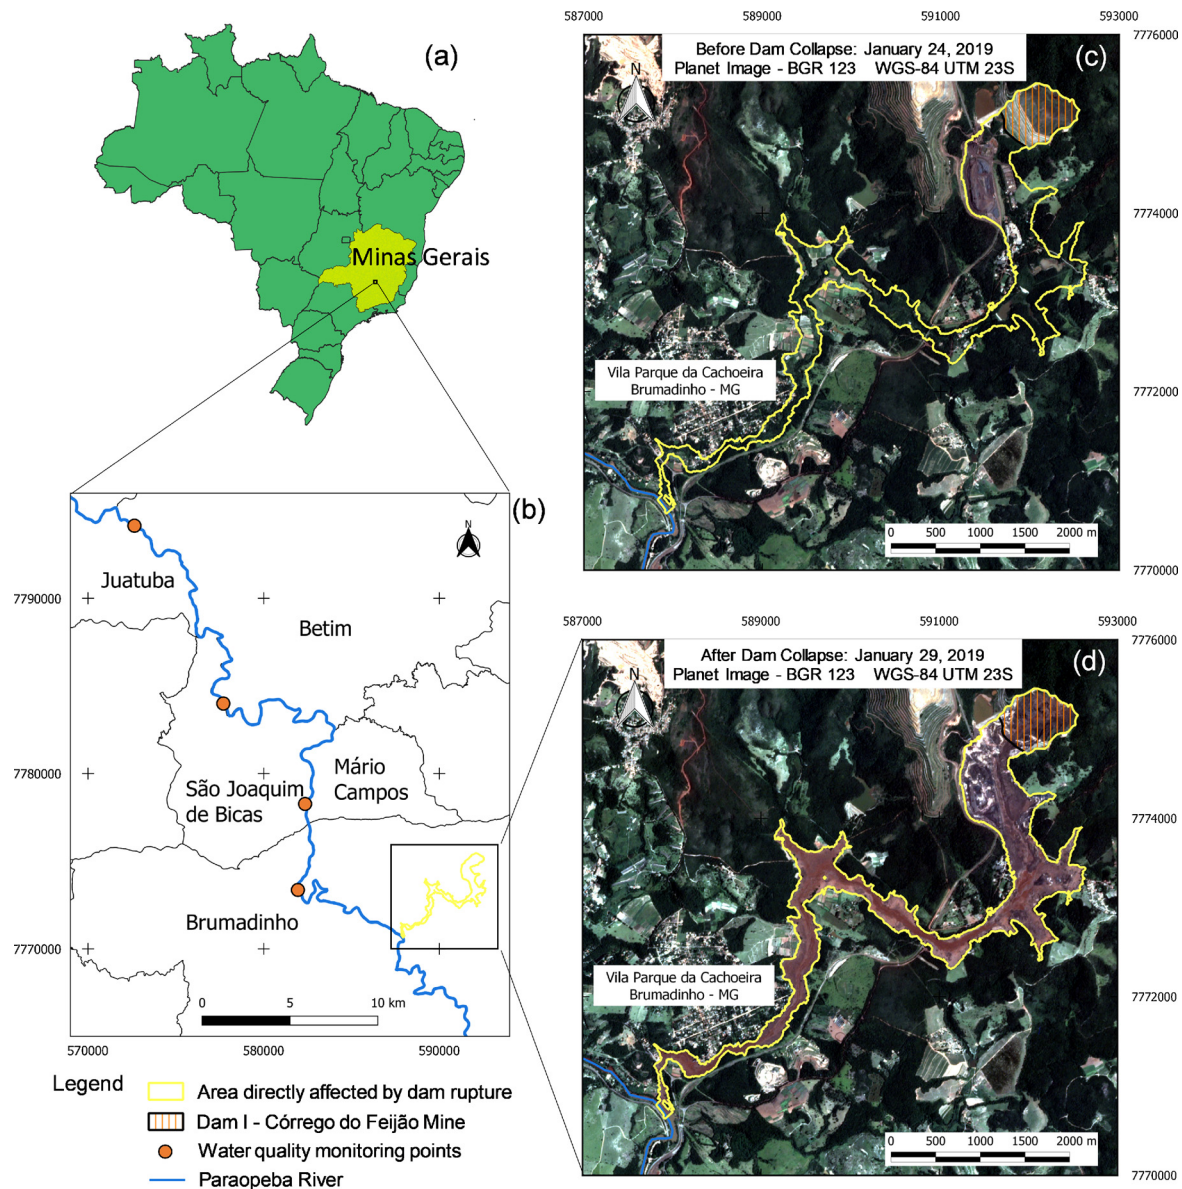
affected by the mudflow (Fig. 1). The mud traveled approximately 10 km, reaching the Paraopeba River. The mud covered an area of  $3.13 \times 10^6 \text{ m}^2$ , equivalent to 450 football fields. The collapsed dam (Dam I - Córrego do Feijão Mine) had an area of  $4.13 \times 10^5 \text{ m}^2$  and approximately 600 m width.

Fig. 1. Study area: (a) Minas Gerais State in Brazil; (b) Paraopeba River and cities near to the accident; (c) before and (d) after images of the dam collapse, indicating the dam location and the area directly affected by the mud wave.

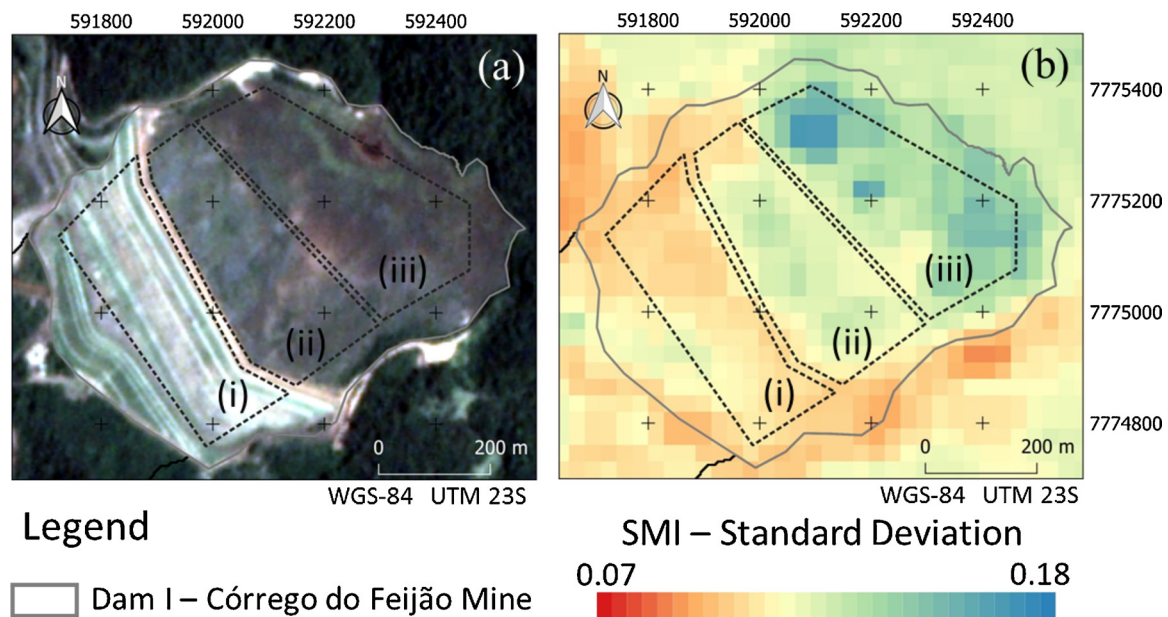
Fig. 2. Planet satellite image from 24 January 2019 (a) and SMI Standard Deviation map from 2011 to 2019 of the Dam I – Córrego do Feijão Mine (b). Three specific sectors of the dam are considered for analysis: Slope (i), Top-of-bench-1 (ii) and Top-of-bench-2 (iii).

Based on the SMI standard deviation map of the dam since 2011, different spatial variation patterns are highlighted that is used to divided the dam into three sections: (i) Slope sector, which hosts the downstream slope of the dam (face); (ii) Top-of-bench-1, which is the area closest to the slope; (iii) Top-of-bench-2, which is sector more distant from the slope that showed relatively higher SMI standard deviation within the dam. The observed higher moisture in the Top-of-bench-2 (iii) was also highlighted by Robertson et al. (2020); these authors showed that the water accumulation near the dam crest allows the deposition of weak tailings near the dam crest.

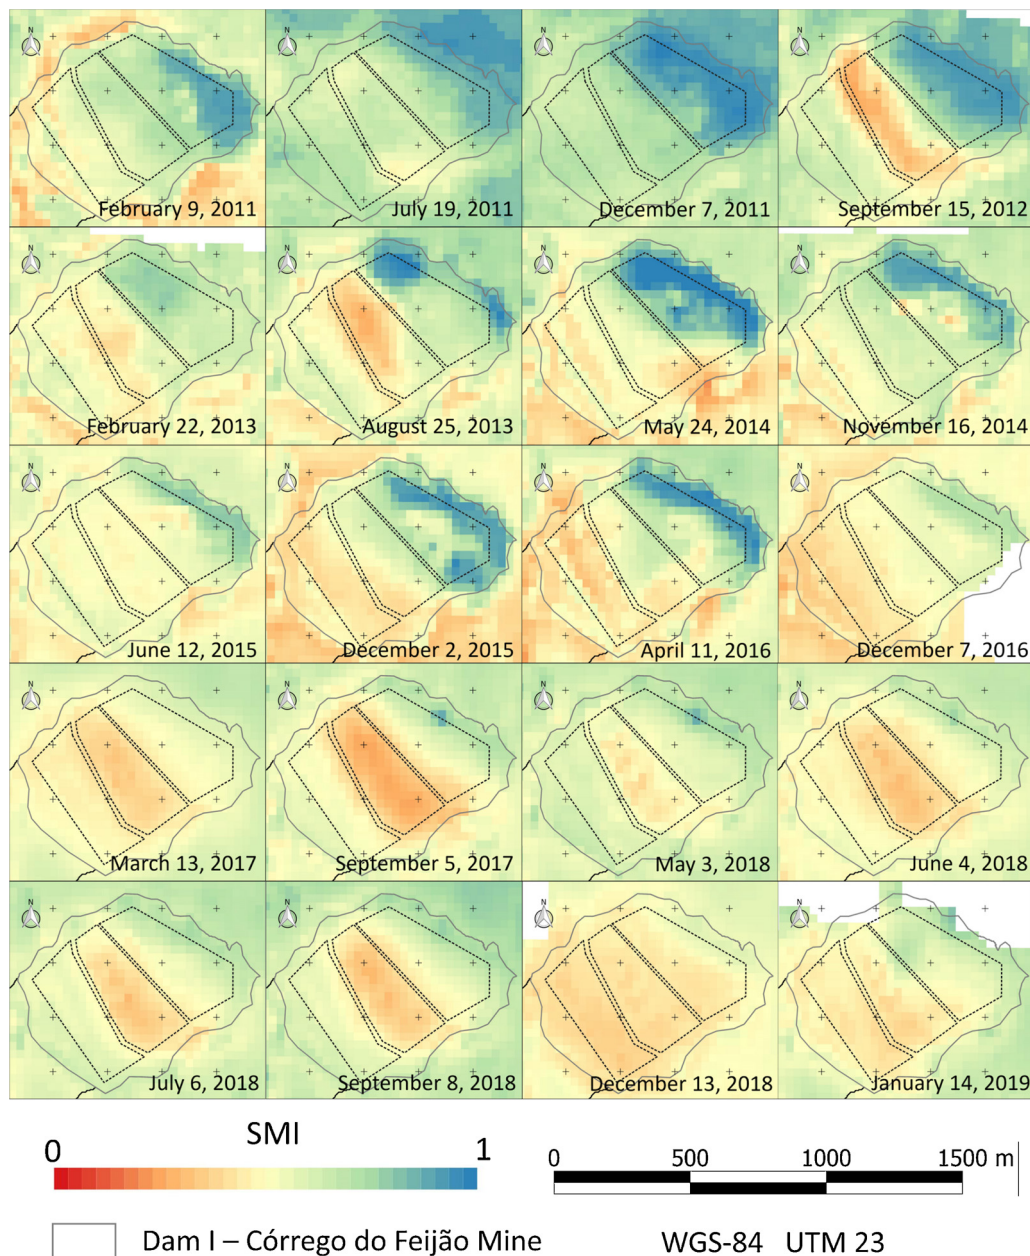
Large tracts with a higher level of moisture were observed in the rear part of the dam (Fig. 3(ii) - Top-of-bench-2) until 2016. At the

Fig. 3. Soil Moisture Index (SMI) from 2011 to 2019 based on sensors/satellites TM/Landsat-5, ETM+ /Landsat7 and OLI/Landsat-8. The white patches represent areas in the images influenced by clouds (i.e., unusable data).

Top-of-bench-2 (iii), a significant water pond was then formed. The SMI for 5th September 2017; 3rd May 2018; 4th June 2018; and 8th September 2018 showed a smaller region with a higher moisture value (including a particular blue “bullseye” in the 5th September 2017 and 3rd May 2018 images), which may indicate a site with external water entry to the dam that might have contributed to increase the water content over the structure. The SMI in the dam by 14th January 2019 (11 days before the collapse of the Brumadinho dam) showed that Top-of-bench-2 (iii) was the sector with the highest moisture at that date, whereas Top-of-bench-1 (ii) and Slope (i) displayed similar SMI values. However, pixels with low SMI values were observed in Top-of-bench-1 (ii), near the transition between the slope and the flat top surface.

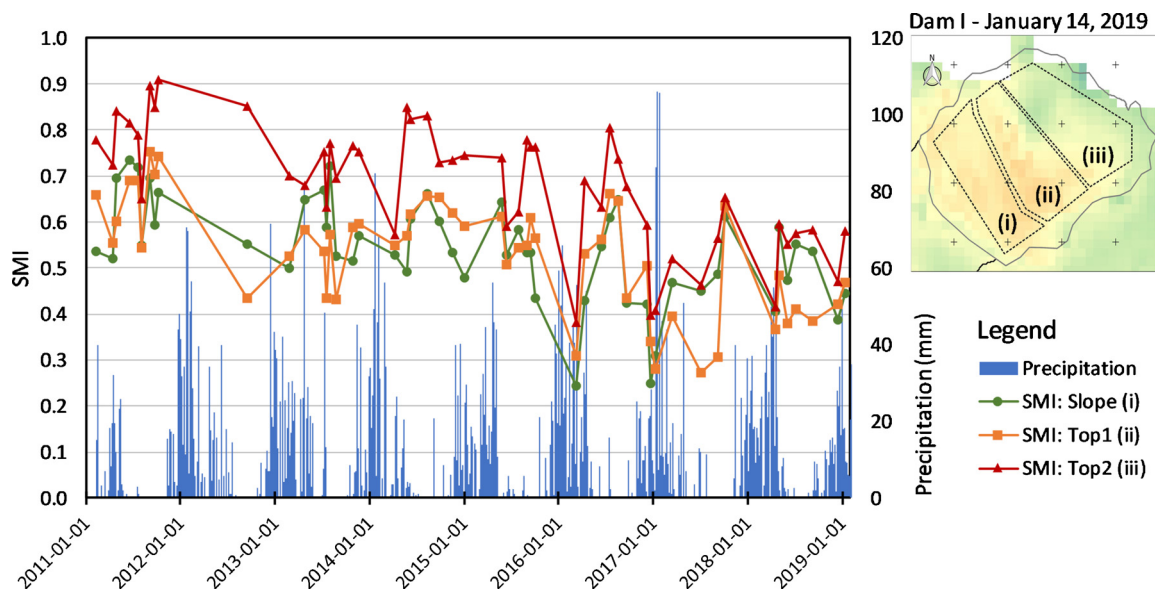
In general, higher SMI values were observed over the Top-of-bench-2 (iii) sector of the dam for the investigated period (Fig. 4). The observed high moisture contents might have implied that this sector was saturated with water. Another behavior observed is the decrease of SMI throughout the dam during the same period. Between 2011 and 2017, Slope (i) and Top-of-bench-1 (ii) showed similar behavior, with consistently lower values compared to Top-of-bench-2 (iii). After 2017, Slope (i) and Top-of-bench-2 (iii) presented similar SMI values. In the rainy season, comparable values were also noted in the three regions. However, in the dry period, the difference between Top-of-bench-1 (ii) and the other regions increases, i.e., the SMI of the Top-of-bench-1 (ii) decreased significantly in comparison to Top-of-bench-2 (iii) and Slope (i). We speculate that the increase in the moisture pattern between the top and the slope sectors, between 2017 and 2019 (i.e. after the dam was decommissioned in 2015), implied that the fill was becoming

Fig. 4. SMI mean value between 2011 and 2019 for the sectors Slope(i), Top-of-bench-1(ii) and Top-of-bench-2(iii) in the Brumadinho tailings dam. Precipitation data from TRMM/Giovanni (giovanni.gsfc.nasa.gov).

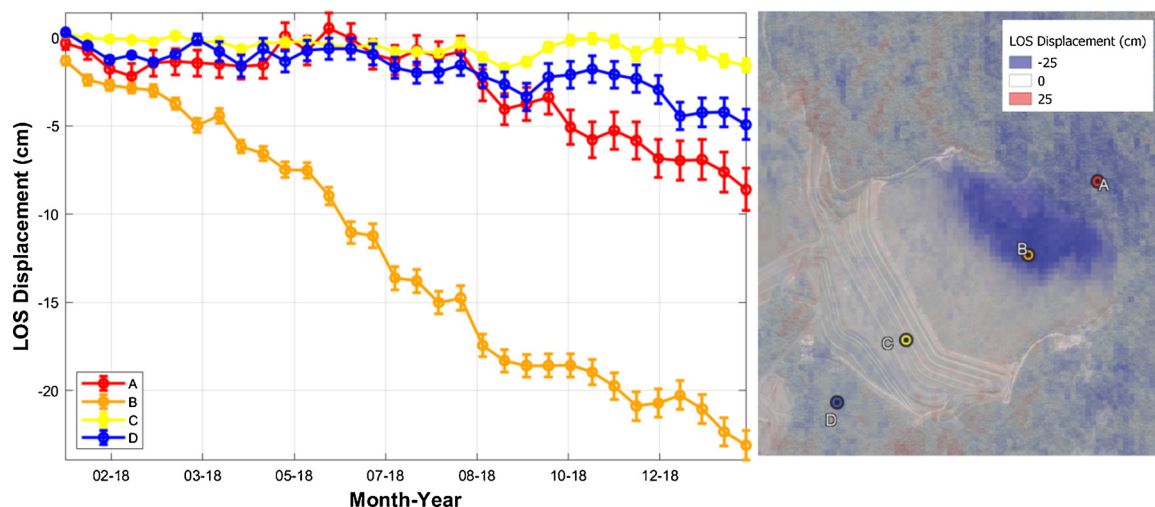
The sector of the dam with significant soil moisture had also sunk over the past few years (Top-of-bench-2, Fig. 4). We also observed the largest LOS displacement in the region, of up to  $-25$  cm between January 2018 and January 2019 (point B in Fig. 5). As there are no concurrent ground-based displacement measurements available, there might remain a slight uncertainty in relation to the subsidence and westward motion, given the sensing direction of the descending path. However, since Top-of-bench-2 is topographically lower than Top-of-bench-1 according to the high-resolution ALOS2 DEM (Fig. 7c), we believe that westward motion is less likely and that the signal was likely to be caused by vertical subsidence. After accounting for the average incident angle of  $32.5$  degrees, the actual cumulative vertical displacement was estimated to be approximately  $-30$  cm.

Besides the deformation within the tailings dam, we also observed creeping in the mountainous area abutting the dam (point A in Fig. 5) which began around August 2018 and continued up to the point the

dam failed. This creeping might have been a result of on-going deformation within the dam and contributed to the final failure process.

Fig. 5. Line-of-sight (LOS) displacement time-series from Sentinel-1 SAR interferograms. The LOS displacement map is for the total cumulated displacement between January 3rd 2018 and January 22nd 2019.

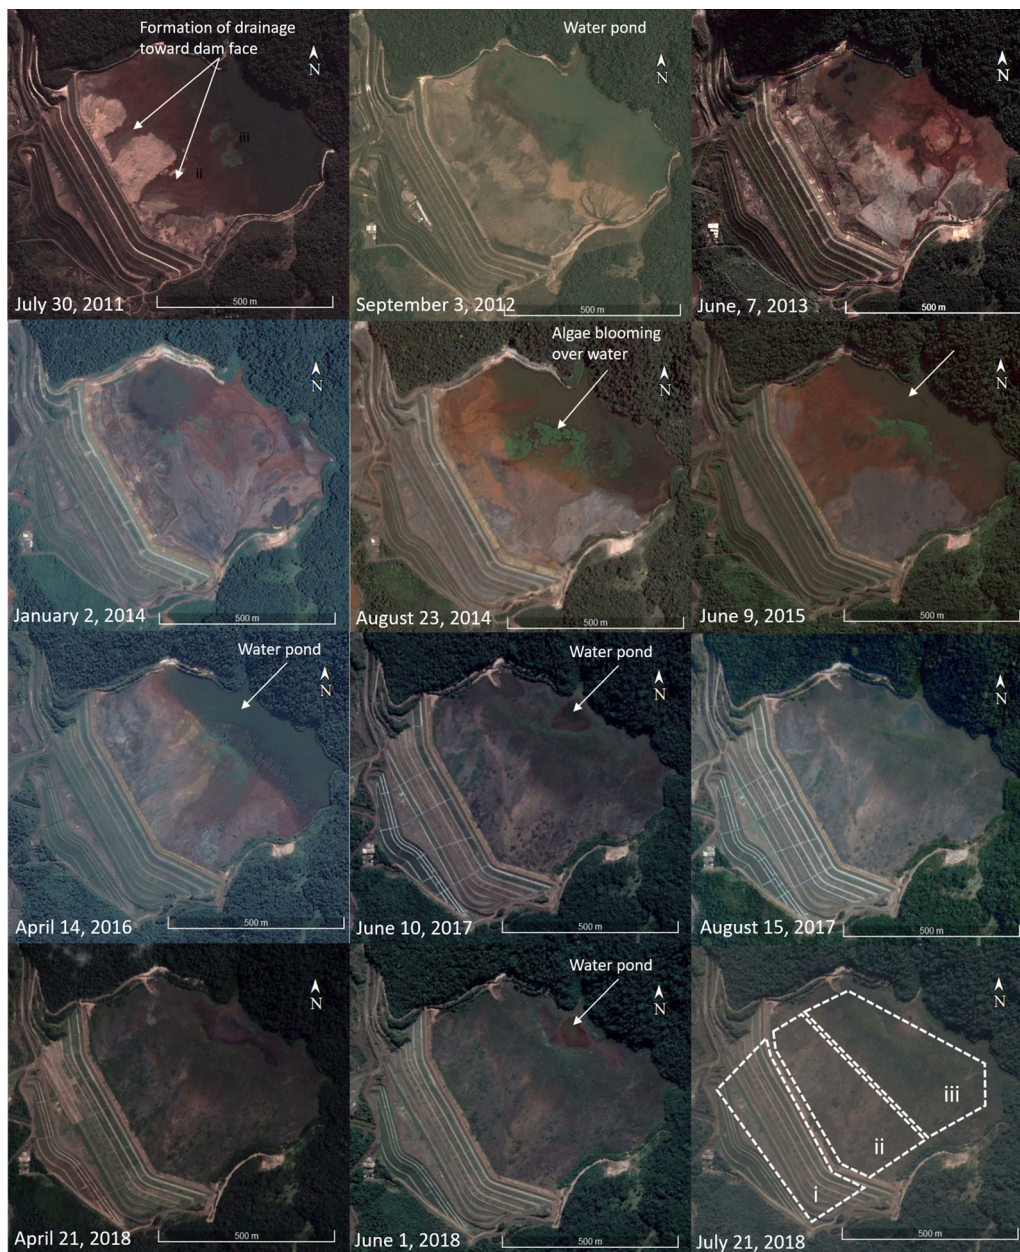
A time-lapse of high-resolution images over the tailings dam since 2011 (Fig. 6) revealed the dynamics of the drainage at the rear part of the dam, where ponds were formed (Top-of-bench-1 (ii)). These small drainages had gradually incised the surface and the ponds seemed to be the resultant depression from both the channel gulying and the gradual subsidence of the fill (as evidenced in Fig. 5). The accumulated water had gradually infiltrated through the fill, causing seepage erosion that led to the removal of material, which is often referred to as “*pip*ing”.

**Fig. 6.** Time-lapse of true-colour images, from Google Earth (2011–2018), showing the formation of drainage towards the dam slope and emplacement of ponds at the planar surface at the top of the fill. This indicates that the water table gradient was reaching the crest of the dam several years before the collapse. Algae blooms throughout the years also indicate that the stagnant condition of the pond has been persistent over time.

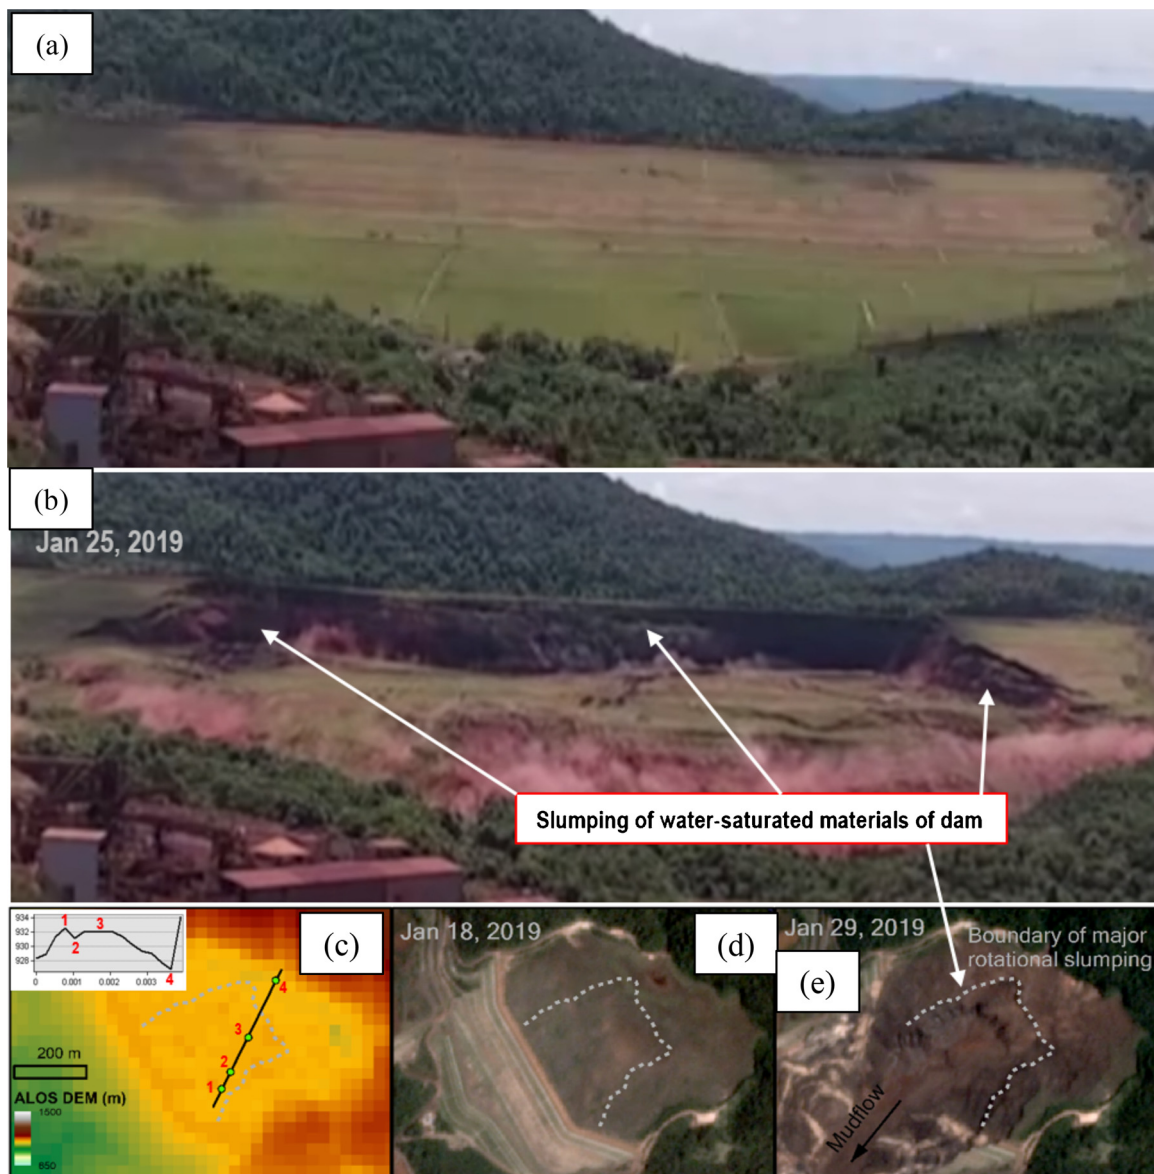
seepage. Upon the dam rupture, it initially seemed like that the failing started at the rear part of the surface (around Top 2(iii)), where the pond was formed close to the mountain area abutting the dam (point A in Figs. 5 and 7b). This failure through instantaneous “slumping” of the fill first happened in this area and was immediately followed by the weakening of the surrounding materials that were saturated with water (Fig. 7b).

The initial collapse at the rear part of the dam, where it experienced dramatic subsidence during 2018 (Fig. 5), triggered similar disturbances and large scale rotational slumping over the other parts of the fill. The mapping of the boundary of the slumping area through high-resolution photographs which were taken immediately before and after the collapse indicates that rotational slumping has occurred on the surface of the dam (Top-of-bench-1 (ii) and 2 (iii) zones) where the shear surface is circular (Fig. 7b, d and e). This implies that the water table was abnormally higher and perhaps reached close to the surface

**Fig. 7.** (a) Screenshot from the movie (<https://www.youtube.com/watch?v=sKZUZQytads>), immediately before the dam failure on January 25th, 2019. (b) Large scale slumping upon the dam failure. This indicates that the bulk of the fill was water-saturated before failure. (c) An elevation profile over the dam surface based on ALOS DEM acquired between 2008-2011. A depression with a depth around 4 m is shown towards the rear part of the fill, where the water pond is present during the wet seasons (Fig. 6). (d) and (e) High-resolution Planet images prior (Jan 18, 2019) and after the dam failure (Jan 29, 2019).

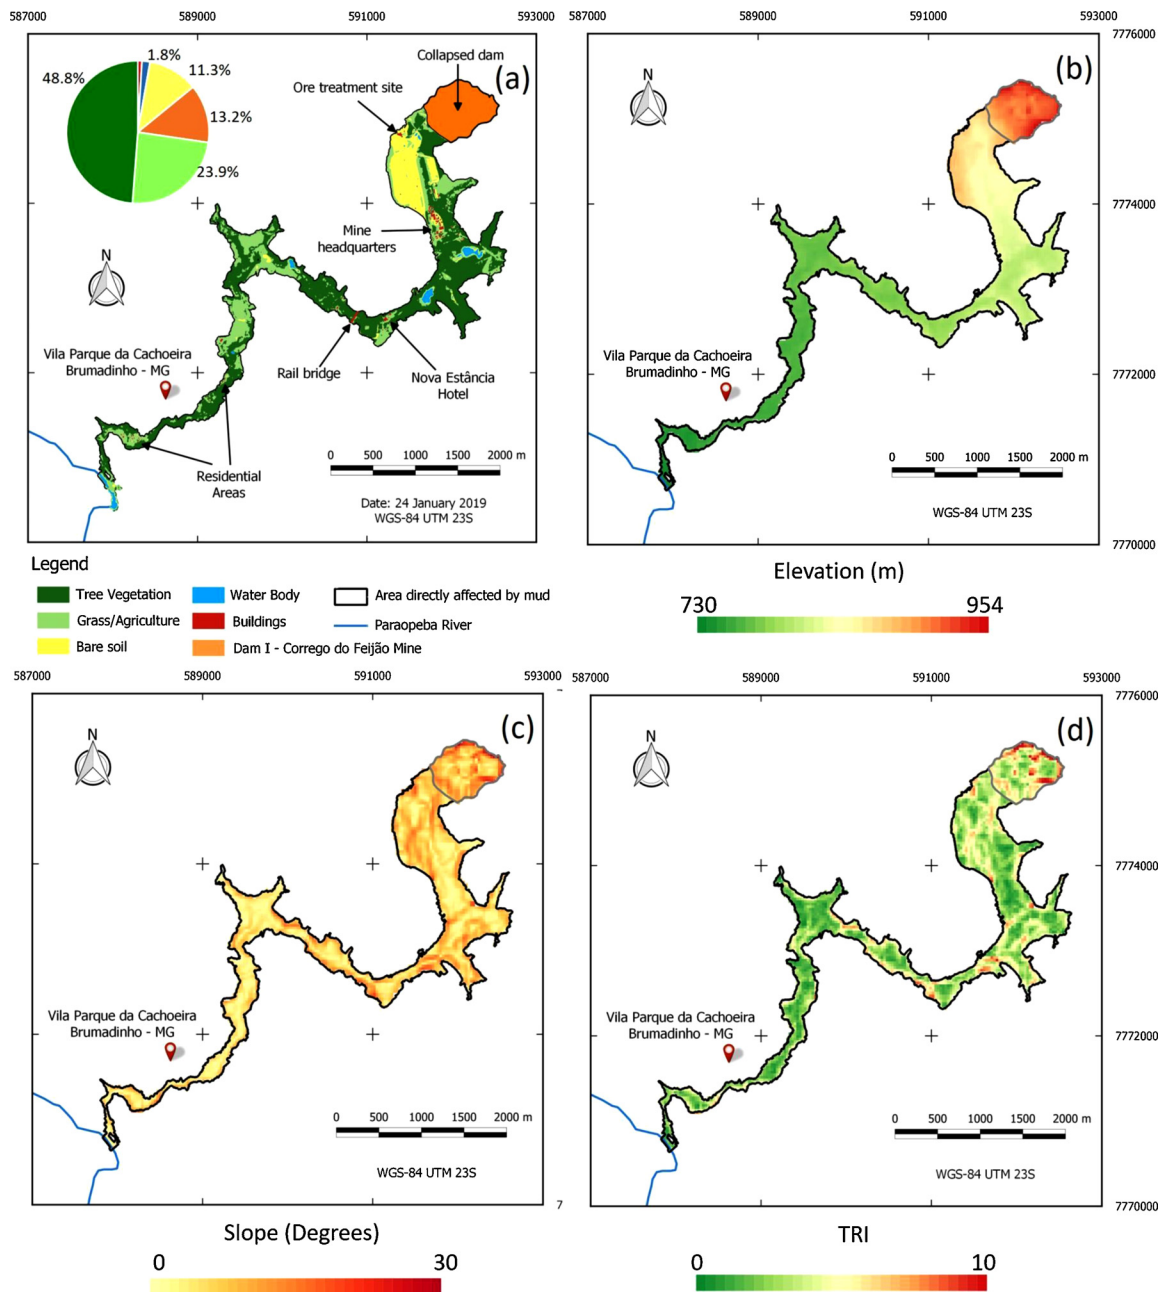
Fig. 8. The LULC map (a), Elevation (b), Slope (c) and Terrain Roughness Index (TRI) (d) of the area affected by the rupture of the tailings dam.

The class “Tree Vegetation” was the most affected by the mud, comprising 49 % of the analyzed area. This implies a huge loss of the ecosystem, with significant impacts on the local flora and fauna. About 24 % of the affected area comprised of regions with grass or agriculture. Agriculture is an important economic activity for people who live in the Vila Parque da Cachoeira. The regions classified as “Bare soil” (11 %) mostly result from mining activities. The tailings dam represents 13 % of the mapped area. The high difference in altitude between the tailings dam and the Paraopeba River (> 200 m as shown in Fig. 8b) and the moderate roughness of the terrain (Fig. 8d) accelerated the mud-flow. The affected area is mainly a mixture of Tree and Agriculture/Grass. Agricultural areas typically have low roughness and mostly occur on flat terrain, whereas trees usually have higher roughness and occupy predominantly steeper surfaces (Fig. 8a, c, and d). Therefore, the roughness of the terrain, depending on LULC, affected the rate at which

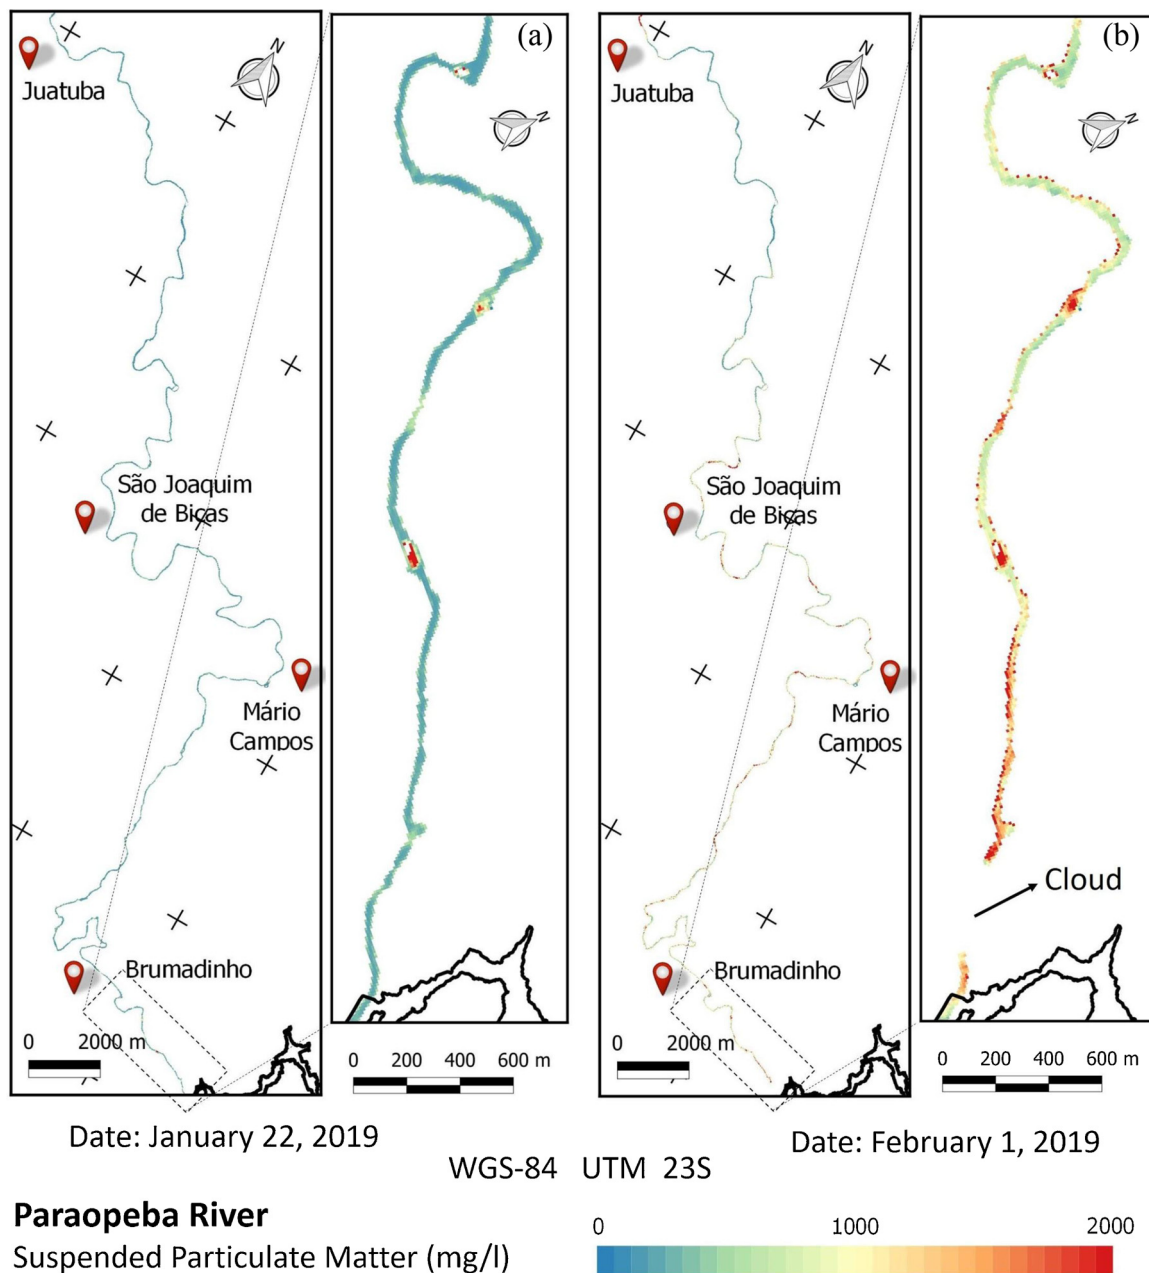
Fig. 9. Suspended particulate matter (SPM) from the affected area and up to 60 km along the Paraopeba River, before (a) (January 22nd, 2019) and after (b) (February 1st, 2019) the dam rupture.

Fig. 9 shows the SPM concentration maps of the Paraopeba River before (January 22nd 2019) and after (February 1st 2019) the dam collapse. SPM boxplots are shown in Fig. 10. Using the median of the SPM concentrations of every 5 km along 60 km downstream, we found a remarkable difference between the two maps (Fig. 10). Although SPM values of up to 3000 mg/l are observed in the boxplot after the dam rupture, only a few points exceeded 2000 mg/l. Thus, to better visualize the difference in SPM concentrations, we used a palette ranging from 0 to 2,000 mg/l.

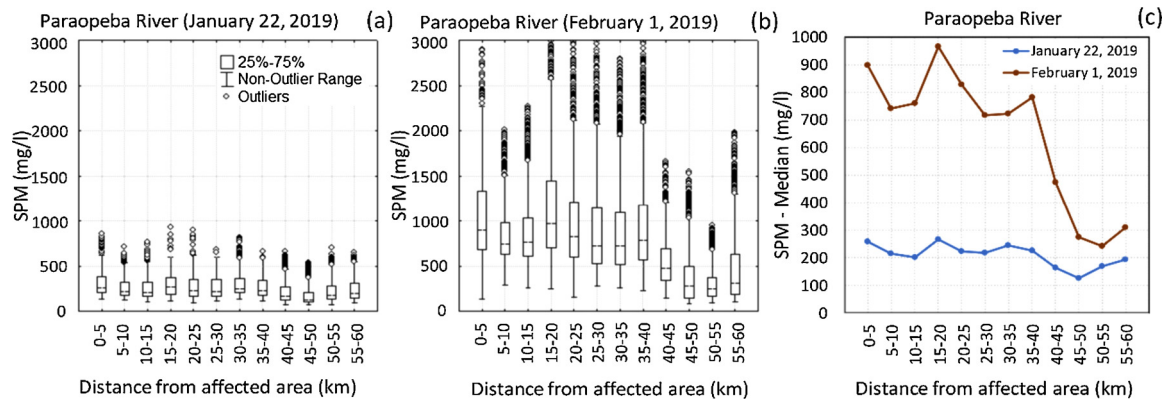
throughout the first 60 km of the Paraopeba river (Fig. 9a), which is also shown in the boxplot (Fig. 10a). Mean values between 200 and 300 mg/l were observed in the river before the dam rupture. On February 1st 2019 (after the accident) the SPM values displayed high variability along the river and the mean concentration dramatically increased, overall indicating the direct impact of the tailings mud. The highest concentrations of SPM (median between 700 and 1000 mg/l) were observed over a distance of up to 40 km. There was a decrease in the SPM values after 40 km; however, SPM values were still higher than those before the dam rupture. We propose that this decrease in SPM values was primarily due to the sedimentation of the suspended solids in that tract, as the river width becomes wider and flow velocity decreased (i.e. due to increased width/depth ratio). An increase in the SPM values on the map of February 1st 2019 was noted at ~60 km from the entry point of mud into the river, close to Juatuba. This increase in SPM may have occurred due to resuspension of solids caused mainly by

Fig. 10. SPM Boxplots from sections extracted at 5 km interval along the Paraopeba river before (January 22nd 2019) (a) and after (February 1st 2019) (b) the dam rupture. SPM median values are given in (c) for efficient comparison.
